Stone Setting Practiced by the Masons of the Naumburg and Meissen Cathedrals— a Comparative Look at Stone Setting Techniques¹

Katja Schröck

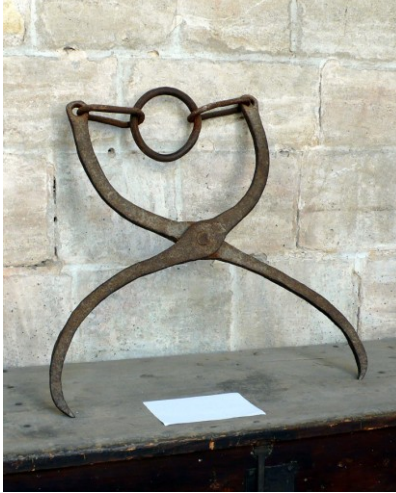
Fig. 2: Kerb Lifter

Another type of fastening is the kerb lifter or external lifter (Fig. 2).⁴ It consists of a pair of S-shaped, forged arms that are fastened together with a bolt and pin or a rivet. At its top end, the kerb lifter has eyes that can take up several chain links. They are tied together with a ring; this ring serves to take up the load attachments.

As a rule, the holes for the lifter are hewn into the face of the stone—i.e. in the front surface—and the rear face of the stone, always above the centre of mass. As the stone is hoisted, the lifter gets stuck in the holes and can be released only after discharge, i.e., after the stone is set down. The shapes of the lifter holes vary and depend on the shape of the ends of the kerb tongs. If we presume that the stone is set using kerb tongs, it was necessary to precisely mark off the lifter holes in advance to ensure the smooth setting of the stones. Such traces of using kerb lifters, i.e. the holes in the ashlar, can be discovered in many constructions. Until now, only these striking traces have been considered. However, I came across a very interesting finding in the Naumburg Cathedral which brings us to the actual subject.

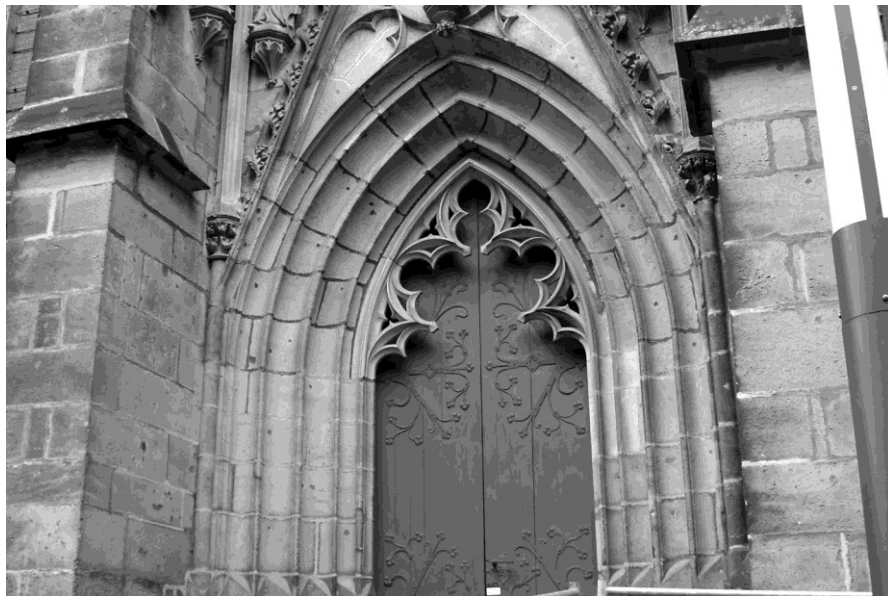
Fig. 8: Filled Lifter Holes on the Outer Walls

On the north wall of the bay of the donors, an exact reconstruction is no longer possible since the stonework was greatly altered as the door was inserted. Only in the six-partite vault the use of the kerb lifter can be proved without the shadow of a doubt. In the polygonal choir, lifter holes are found only on the external wall. They can be seen only at a height of several stone layers above the window sills of the choir windows. Starting from the diagonal cut described, the group of masons decided to adopt a different stone setting technique and stuck to it throughout the process. From that point, the masons used the kerb lifter even in the lowest stone layers, although it was quite possible to set the stones without fastenings. The kerb lifter was used not only for simple ashlar but also for the voussoirs in the southern portal. Finally, the lifter holes in the facing were filled with mortar that was coloured to match the stone. To achieve this, the fine rock powder that was produced as a by-product of hewing was mixed with mortar. Inside the cathedral, the filled holes are visible only to the keen observer, but on the outer walls the holes are easily identifiable nowadays since the stone developed a patina while the mortar did not. As a result, the lifter holes contrast with the stone in terms of colour (Fig. 8).⁶

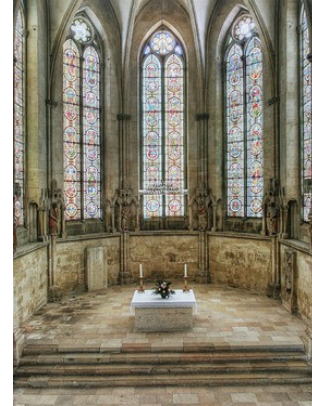
Fig. 9a: Naumburg, West Choir, Floor Plan

Upon close examination of the west choir (Fig. 9a, 9b) of the Naumburg Cathedral, one will soon discover that the kerb lifter was used only now and then. Regular use of the kerb lifter started only very late in the process.
