Wooden reinforcements in Byzantine masonry: A rough guide to their position and arrangement¹

Athanasios Koumantos

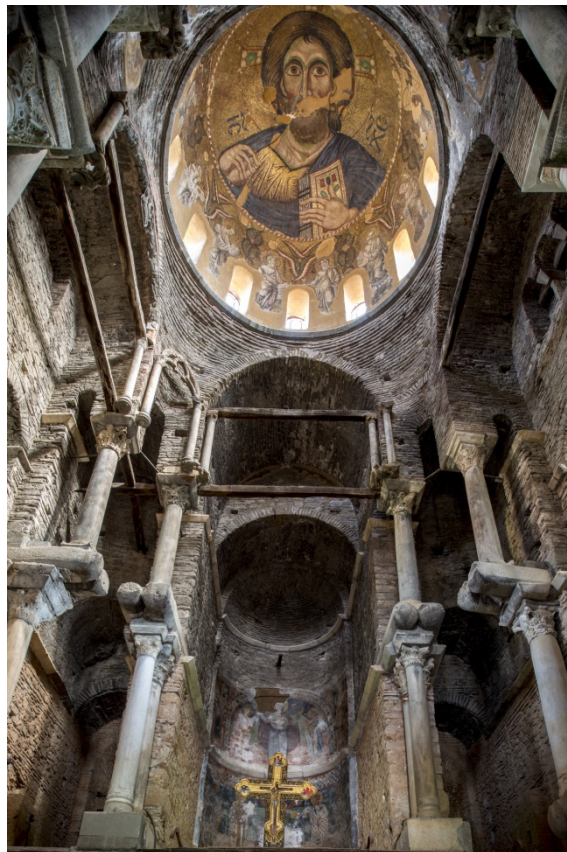
Fig. 4: Panagia Parigoritissa, Arta, Epirus, interior (May 2005)

A second, almost equally conspicuous location where such exposed tie beams, connected to respective wooden reinforcements throughout the walls at the same height, are routinely found is at the springing of arches and vaults (fig. 3, 4). In fact, in certain cases this level coincides with the previously described one over the columns or piers. Both Velenis and Ousterhout have already explicitly indicated this level as a location where wooden reinforcements were consistently used.

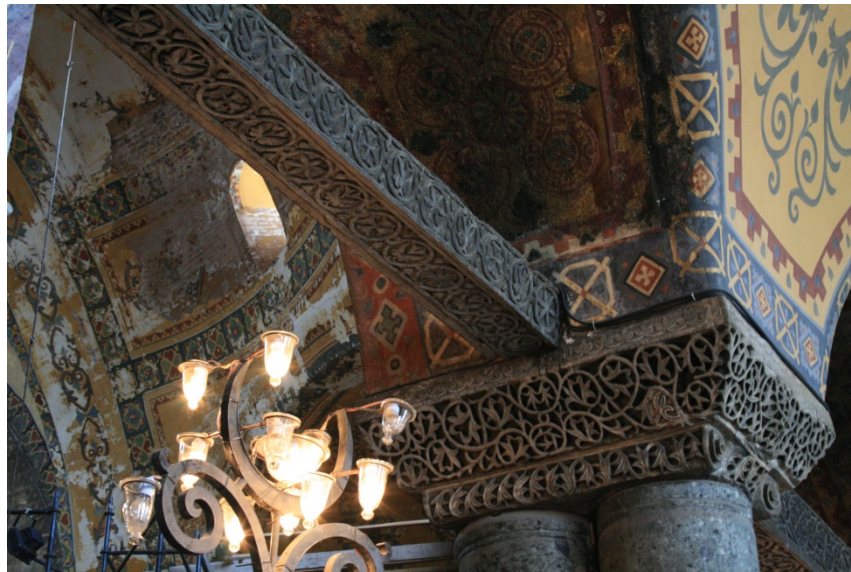
Fig. 5: Hagia Sophia, Istanbul, decorated tie beam in the west gallery (July 2010)

In many cases, these tie beams were left in place after construction, and sometimes even decorated further, as in the case of some conspicuous wooden ties in Hagia Sophia (fig. 5)¹², as they continued to serve their function of helping to keep these slender elements in place¹³. In other cases, they were cut off for various reasons, one of them being to allow for a subsequent drawing program to be realized, as in the case of the central wooden ties at the 10th c. Katholikon of Vatopedi Monastery on Mount Athos¹⁴ (fig. 6).

¹² See further, Sheppard 1965. For this paper, wood specimens were taken from both the beams in the west gallery of the Hagia Sophia, as well as the decorative planks covering them. These were carbon dated to 470±70, and 830±70 respectively.

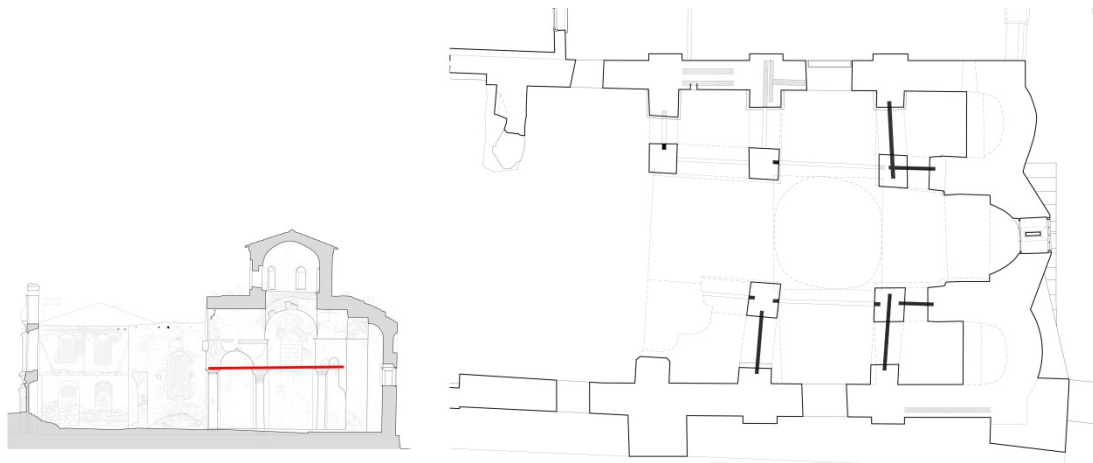
Fig. 7: Panagia Pantovasilissa, Trigleia, plan and longitudinal section showing the surveyed wooden reinforcements at the level above the columns (Mamaloukos and Kamboli 2013)

wooden reinforcements within the walls at the same level, and that these tie beams extended along the longitudinal axis, but also, perplexingly, that these did not extend along the transverse axis within the church (fig. 7).

On the other hand, the window sills, regardless of the exact height on which they appear, are an area where wooden elements, otherwise embedded in the walls, might be readily discoverable, as was the case in the church of Panagia Pantovasilissa in Trigleia (fig. 7).

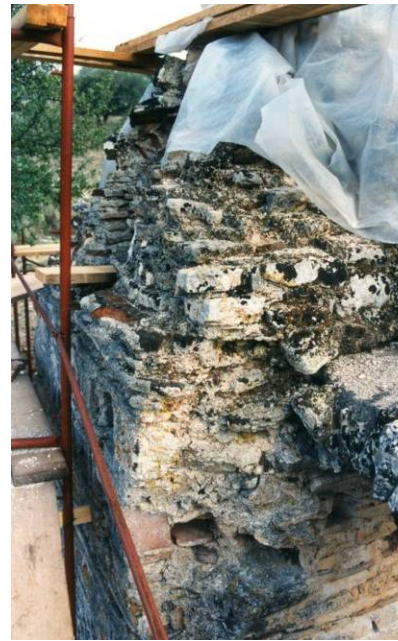
Fig. 13: Hagios Stephanos, Rivio, , traces of wooden reinforcements at the springing of cross-arm barrel vaults (Mamaloukos and Kamboli 1995)

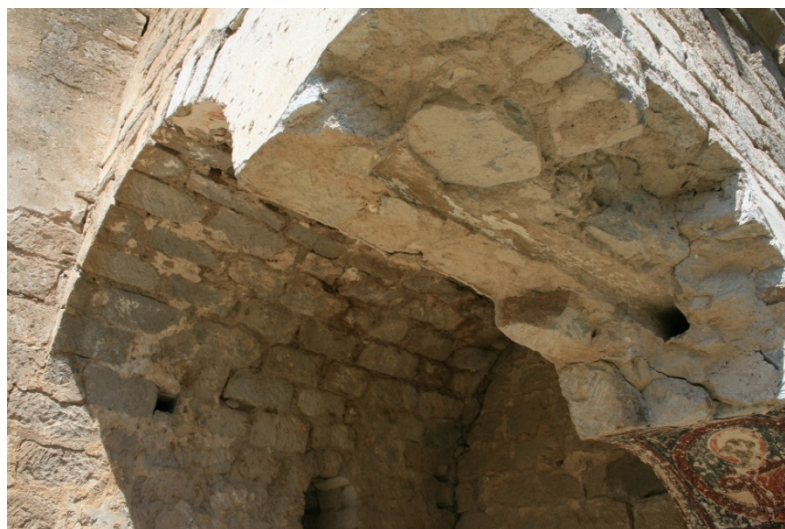
Fig. 14: St. George church (Karagedik Kilise), Peristremma (Belisırma), Cappadocia, cavities left in the place of notched wooden reinforcements at the springing of the vault in the NE corner (July 2009)

Finally, the rule of integrated wooden reinforcements at the springing of arches and vaults also holds for secondary, i.e. lower, arches or vaults as well, as was found in the 11th c. St. George of Peristremma church (Karagedik Kilise) in Cappadocia (fig. 14), where a collapsed pier revealed the, otherwise completely hidden, single wooden beam along the northern bema wall, to which the exposed tie beam of the northeast corner bay was anchored.

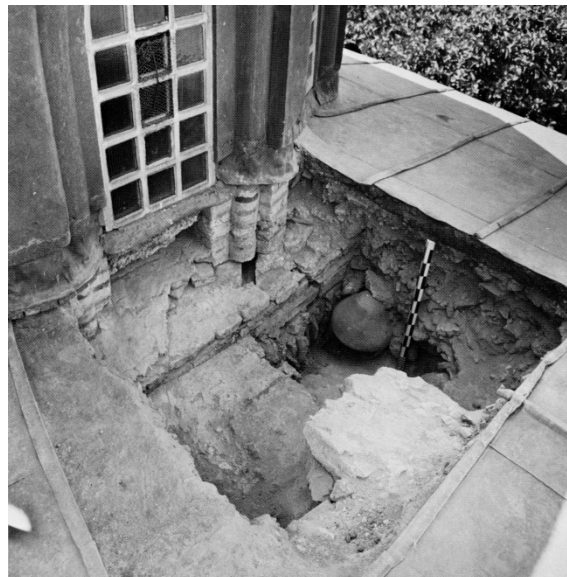
Fig. 15: Chora church (Kariye Camii), Istanbul, exterior view of the extrados of the Parekklesion during the 1980s excavation (Ousterhout 1987, Fig. 152)

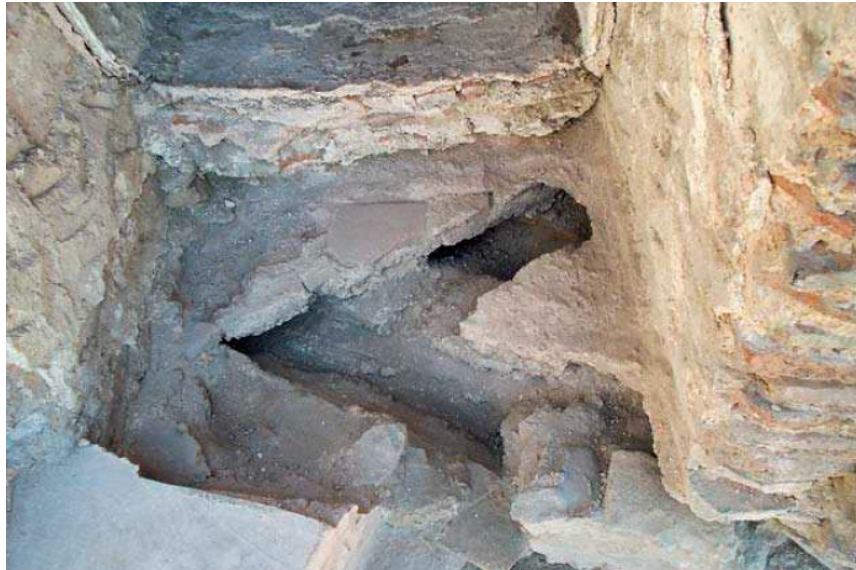
Fig. 16: Christ Pantocrator chapel (Zeyrek Camii), Istanbul, window reveal of the west central dome, showing the cavities for reinforcement beams at its base (July2003) (Ousterhout et al 2010, Fig. 7)

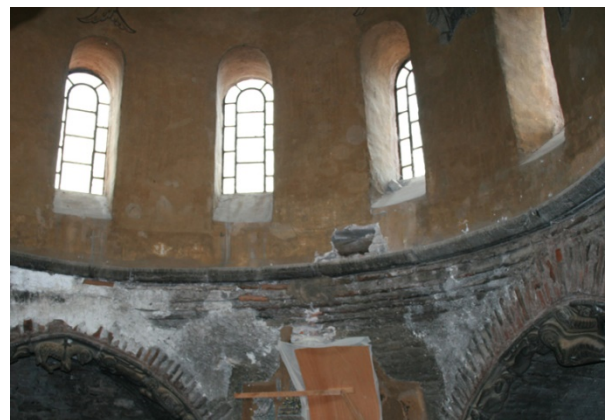
Fig. 18: Parigoritissa, Arta, interior view showing wooden reinforcement at base of the central dome drum (Miltiadou - Koumantos 2005)

In Panagia Parigoritissa a wooden reinforcement chain was located on the interior side of the base of the central dome, hidden behind the plasterwork (figs. 17, 18). It was impossible to ascertain whether a similar wooden reinforcement run along the exterior face as well. We must point out that, contrary to the other two examples, it was located well below the window sills, and also clearly above the height of the stone cornice on the interior.

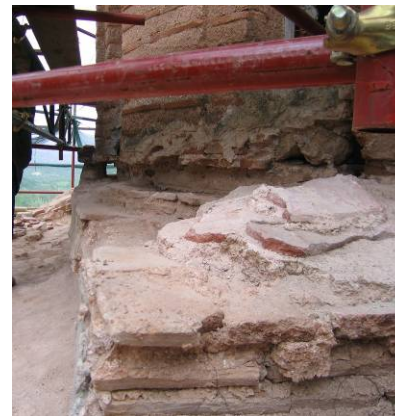
fig. 20 Panagia Krina, Chios, exterior view showing the position of wooden reinforcements at the base of the dome drum (Vintzilaiou 2006)

In Panagia Krina, during the restoration project, two rows of wooden reinforcements were discovered at the base of the central dome drum, one flush with the exterior face, and another on the interior just below the window sills, but at a distance from the interior face (figs. 19, 20). It is noteworthy that at this height, the wooden elements accounted for over fifty percent of the thickness of the masonry wall. This was not the only wooden reinforcement system of the dome drum base, however. Another one was later discovered about 30 cm below it, this time reinforcing the sensitive area of the rectangular pedestal base of the drum, and which corresponded to the spherical surface raising the base of the dome over the supporting conches (figs. 21, 22). In Panagia Krina this level of wooden reinforcements was laid out in a single row, in an octagon, or truncated rectangle.

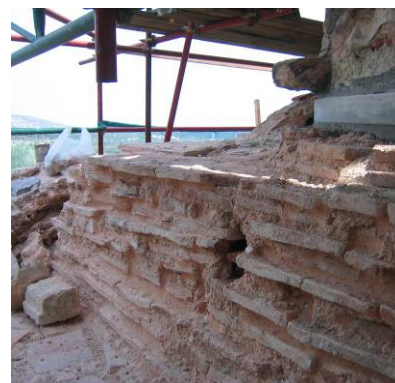
Fig. 22: Panagia Krina, Chios, exterior view showing position of wooden reinforcement at the rectangular base of the central dome (Vintzilaiou 2006)

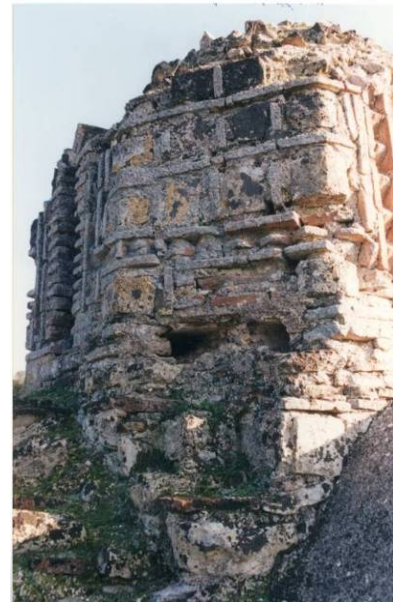
Fig. 24: Hagios Stephanos, Rivio, , traces of wooden reinforcements at the base of the dome drum
(Mamaloukos - Kamboli 1995)

In other monuments though, such as the 13th c. church of Hagios Stephanos, in Rivio, Western Greece, where the level of the rectangular pedestal base coincides with the base of the drum, only one level of wooden reinforcements was found, laid out not in a circle around the drum, but rather in a single-row rectangle around the base (fig. 23, 24)²³.

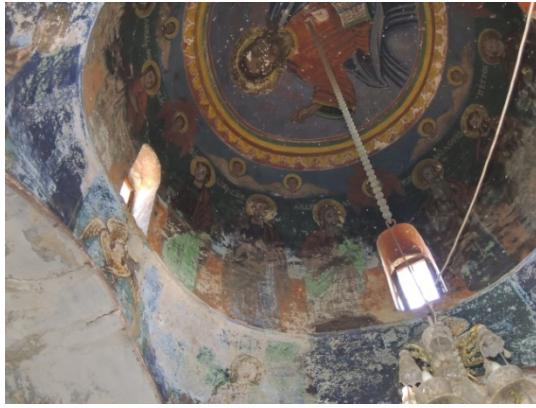
Fig. 25: St. Mary, Kosinë, Albania, view of wooden reinforcement ring at the base of the drum on the interior (September 2014)

On the other hand, in the church of St. Mary in Mary, Kosinë, Albania, a similar to the above, Despotate of Epirus church (fig. 25, 26), two quite different arrangements are found simultaneously on the same level; a circular wooden ring on the interior above the cornice, and a double row of rectangular arranged reinforcement beams visible on the exterior within the rectangular pedestal base of the drum. These two arrangements might also be interconnected, but that would require additional in-situ investigation to ascertain.

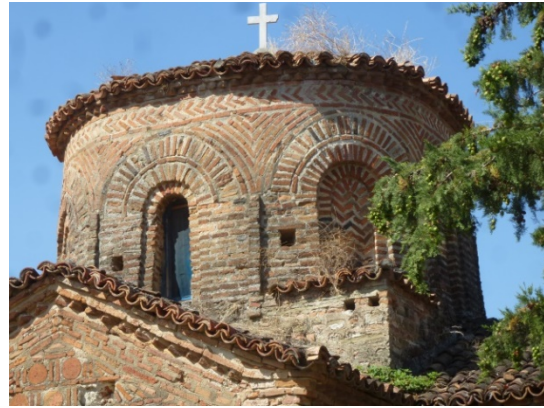
Fig. 26: Mary, Kosinë, Albania, view of wooden reinforcements at the base of the drum on the exterior (September 2014)

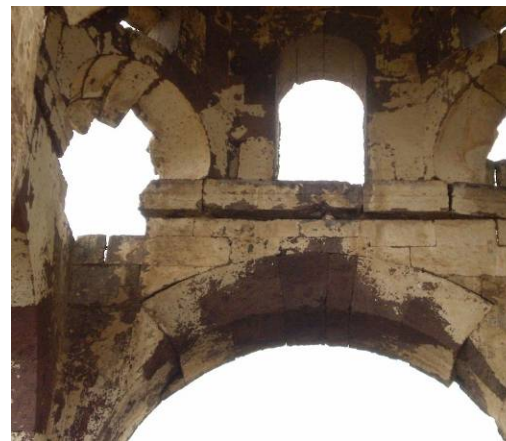
Fig. 28: Kizil Kilise, Cappadocia, interior view showing traces of the wooden reinforcements at the base of the dome drum and squinches (July 2009)

Yet another permutation of such a system can easily be seen, even today, in the 6th c. Red Church (Kizil Kilise) in Cappadocia²⁴ (fig. 27, 28). Here, the octagonal dome drum rests on the square main church walls via squinches. In this case, a double row of wooden reinforcements was laid at the base of the squinches, which in this manner coincide with the base of the dome drum. This is a particularly interesting, albeit perplexing, example, as it is an early Byzantine church, no traces of other wooden reinforcements are to be found in the rest of the church, the wooden elements are completely exposed, even though they are embedded in the masonry, and finally it is an ashlar masonry monument, as opposed to the majority of brick or rubble masonry churches discussed in this study.

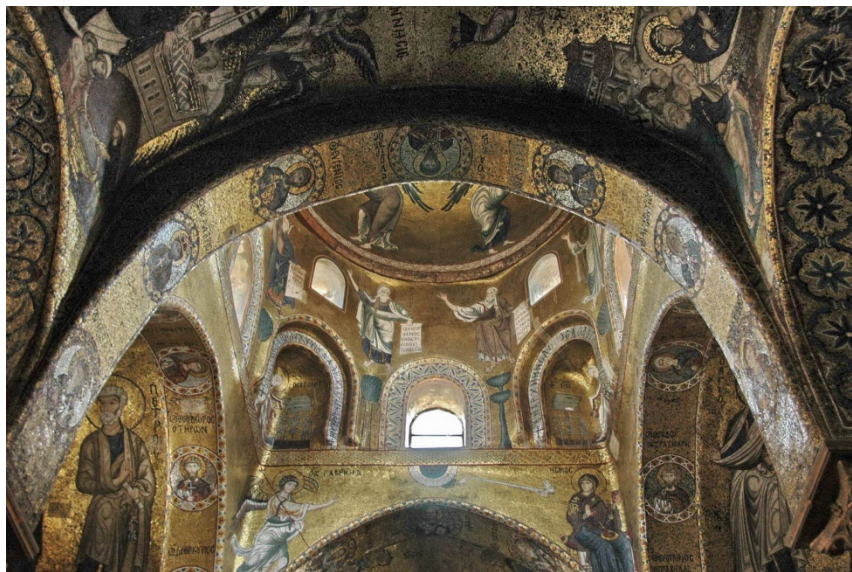
Fig. 29: St. Mary of the Admiral (Martorana), Palermo, view of the interior showing the transition to the dome

An almost identical wooden reinforcement arrangement has been encountered in the 12th c. church of St. Mary of the Admiral (Martorana) in Palermo (fig. 29), a church just beyond the western end of the Byzantine world, and some six centuries later. Here, the dome drum includes the squinches that make the transition from the square main church walls, to an octagonal drum, and then to the round dome. As Ćurčić reports²⁵, two distinct levels of continuous wooden reinforcements were discovered during the restoration works: the lower one was composed of four pairs of beams, a pair above each of the main arches, i.e. at the base of the four squinches, presumably linked to each other, and the higher one a continuous wooden chain hidden behind decorative planks at the springing of the dome.

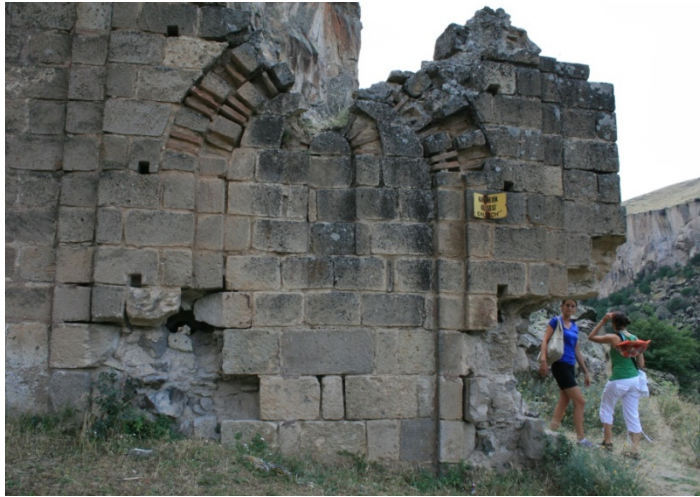
Fig. 34: St. George church (Karagedik Kilise), Peristremma (Belisırma), Cappadocia, continuous wooden reinforcement below the window sills (July 2009)

In the church of St. George (Karagedik Kilise) in Cappadocia where *'some of the putlog holes appear in the stone courses with a notch cut into the stone'*²⁶ it was found that these putlog holes were indeed rather shallow and isolated from the single row wooden reinforcement running along the center of the masonry wall, just 10-15 cm below (fig. 34, 35). This wooden reinforcement is visible in two partly collapsed areas along the south façade, and hence we must assume that it ran continuously throughout the church walls at this height. Indeed, it might further be assumed that the churches that have wooden reinforcements higher up their structure, in all probability also possess structural reinforcements at this height as well.

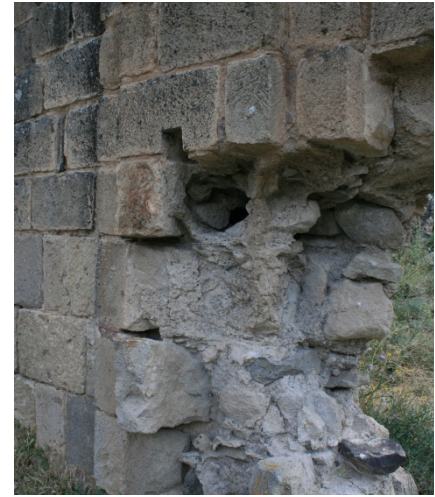
Fig. 35: St. George church (Karagedik Kilise), Peristremma (Belisırma), Cappadocia, closeup of wooden reinforcement and putlog hole below the window sills (July 2009)

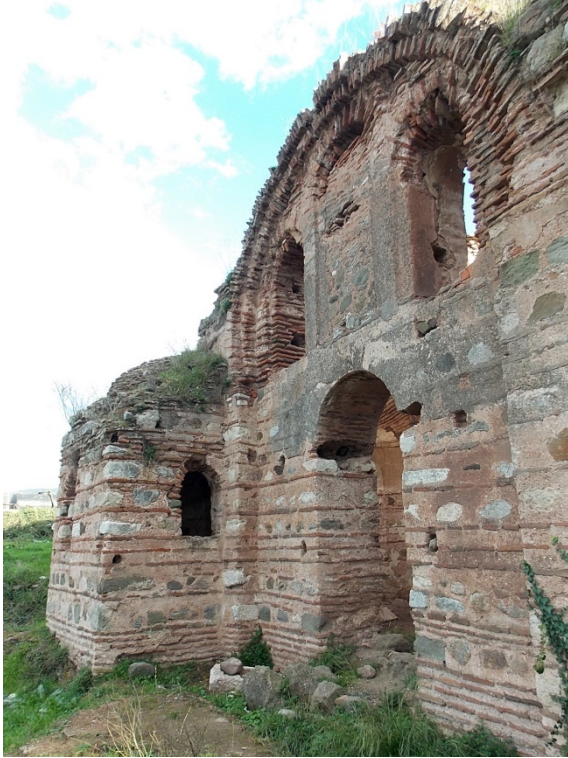
Fig. 37: St. Abercius church, Kurşunlu (Elegmi), Bithynia, staggered connection between exposed beam and built-in wooden reinforcements (three more wooden reinforcement systems, one below and two above, are also discernible) (March 2013)

Nevertheless, a possible solution to this seeming discrepancy was revealed in the 11th c. church of St. Abercius at Kurşunlu (Elegmi), Bithynia (fig. 37). Here the exposed beams at this height were actually to be found in the springing of the arches of the side doorways. As none of the wood elements has survived, their exact positions and connections are to be seen in the cavities left in their place. Interestingly, in this case, the exposed, single wooden beams at the springing of the arch were connected, via a transverse wooden element, to a double row of wooden reinforcements within the walls some 10-15 cm above the level of the springing, in a staggered manner. As a matter of fact, this system of wooden reinforcements ran exactly above the arches of the windows, which are somewhat lower than the doorways.

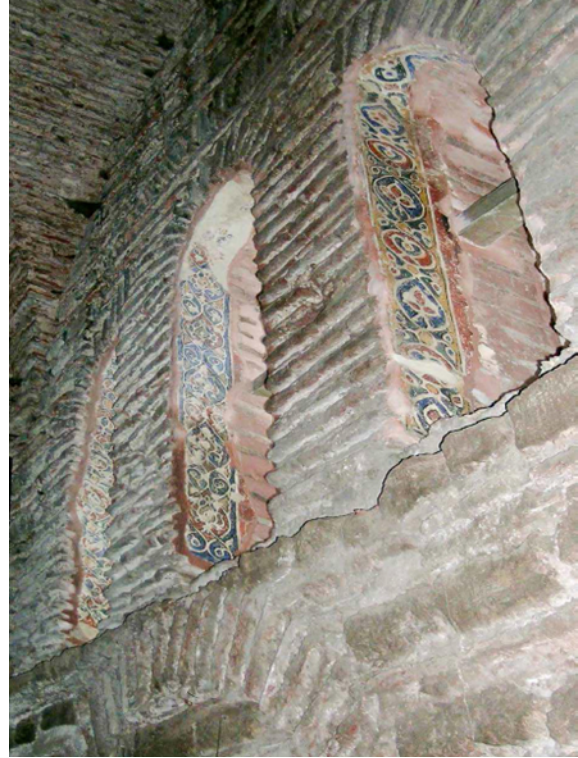
Fig. 38: Zeyrek Camii, exonarthex, windows in north wall with surviving wooden beams at mid height (Ousterhout et al 2010, Fig. 18)

A pertinent side note here would be that wooden reinforcements can sometimes be found, not only on the window sills, or the springing of window arches, but at mid height of windows as well, especially in triple windows under an arch. Available examples, are few, and belong to otherwise correlated churches as well, such as St. Abercius at Kurşunlu (fig. 37), and the north wall of Zeyrek Camii in Istanbul (fig. 38)²⁹, but nevertheless they must be noted here.

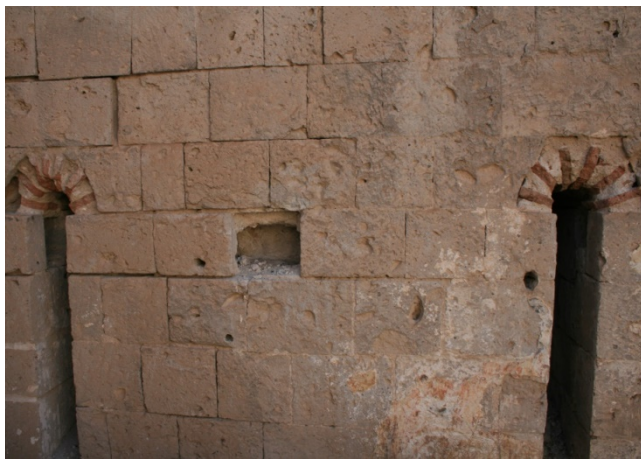
Fig. 40: Çanlı Kilise, Aksaray, Cappadocia, continuous wooden reinforcement at the springing of the main window arches, interior looking north (July 2009)

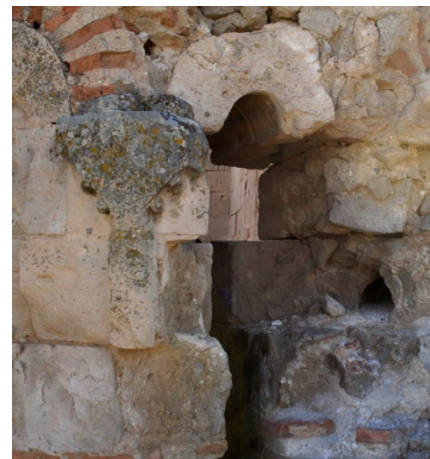
Fig. 41: Çanlı Kilise, Aksaray, Cappadocia, continuous wooden reinforcement at the springing of the main window arches, east façade (July 2009)

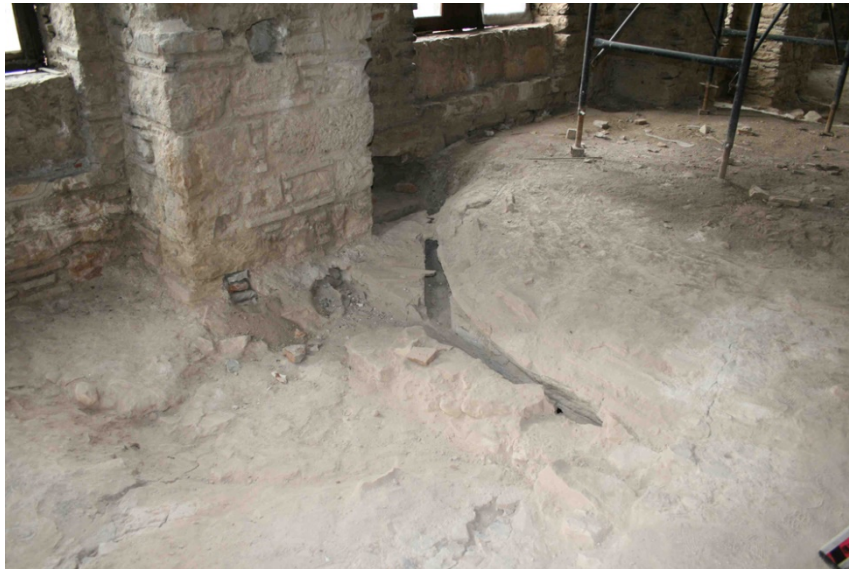
Fig. 50: Panagia Parigoritissa, Arta, cavities of wooden reinforcements in the dome vaults of the gallery (March 2007)

However, the most remarkable area where wooden reinforcements were discovered is in the church of Panagia Parigoritissa, in the floor of the upper level gallery. This floor lies over the ground floor gallery vaulting, and consists of groin and dome vaults, resting on reinforcing arches on the north and south galleries, but without any such arches on the west (fig. 50). Again here, almost no traces of wood remain, but the exact positions and dimensions of the wooden elements were transferred onto the surface of the building mortar in which they were embedded. It must be noted that especially in the dome vaults the wooden reinforcements extended almost throughout the width of the masonry vaulting, in a way substituting the stone building material in these positions. These wooden beams formed an octagon, on which the lowered dome was subsequently built.
