The hamam is located on a downward slope to the west of the main cobblestone road leading towards the castle and near an Ottoman fountain (fig. 3). In a 1931 photograph it appears that a house was built above the hamam, meaning that the Ottoman structure became a part of the ground floor and basement of that house. The bath was unearthed when that residence was torn down in 1990 (fig. 4). Restoration work was limited to the debris removal and to the excavation of the main parts of the bath without expanding to the rest of the building, which continues towards the south and west sides⁷.

It seems that it was a simple and small community (public) bath (fig. 5), as were most of the baths in Greece. Only a section of its main area still survives, with a size of ca. 3.8 X 6.5 m (maximum), comprising the hot room as well as two reservoirs for gathering and heating the water. Other essential areas are missing, such as the disrobing and the tepid section, which must have been on the south or west side.

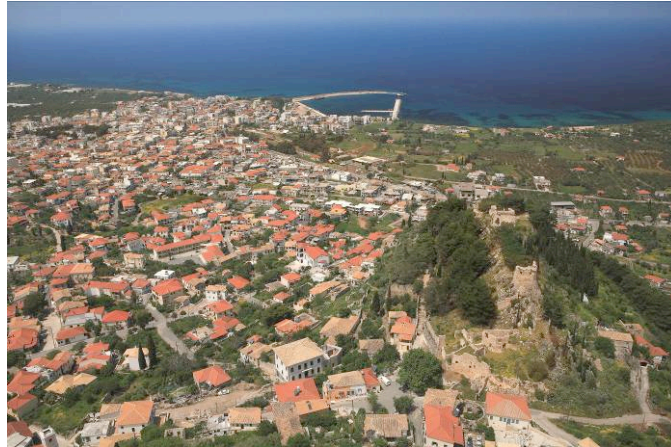
Fig. 2

construction, that went through a number of alterations and interventions, during the Ottoman and Venetian dominance² (fig. 2).

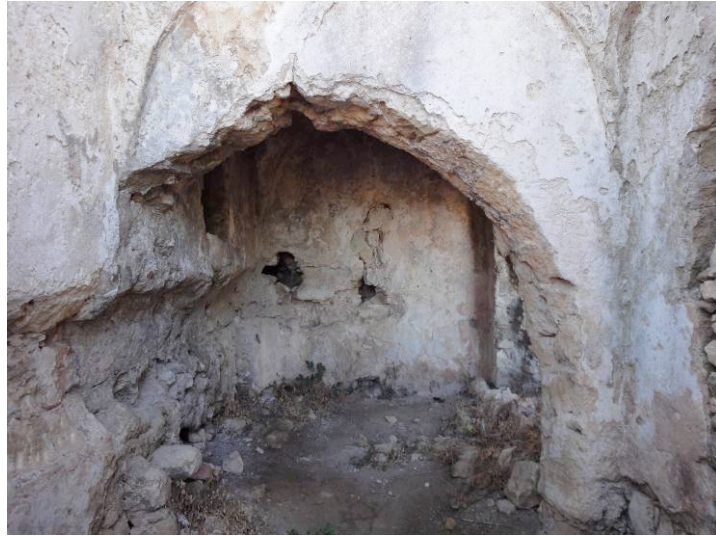
Fig. 6

The hot room (“sicaklik”), is divided by an arch in two almost square areas under lowered semispherical domes, one of which is partly destroyed today (fig. 5(1), fig. 6-7). Their octagonal base was mounted on pendentives as was customary in buildings of the 16th – 18th c.¹² Such pendentives can also be found in one of the towers of the castle, presumably remodelled under the First Ottoman rule. The

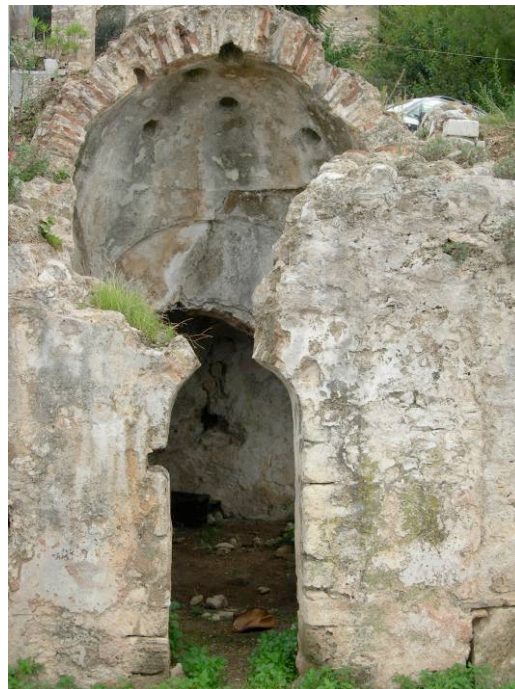
Fig. 8

The narrow entrance is 70 cm wide, built with hewn stone doorposts and a clay brick arch (fig. 8). It was most likely the door connecting the hot with the warm room. We can detect on its wall the spouts of ceramic pipes for the transfer of warm air towards the missing room. Two more arched openings are formed on the south side (fig. 9). The eastern one was opened at a later stage. The western one possibly existed in the original layout of the building but was initially smaller, widened later and then hastily covered up. On the northern wall, at about 1.5 m. above the floor, there is a small arched opening providing direct contact with the hot water container and fenced off by means of an iron grate (fig.6). The air circulated into the hot room through that opening, assisted by ceramic pipes embedded in the walls, and hypocausts, partly revealed at the west side of the building. The underfloor pillars were made of square clay bricks and only two rows of these, about 20 cm high, still survive. At the north-west corner a small section of the original floor can be seen, covered in stone slabs (fig. 10). Only six of the documented hamams in Greece preserve that type of hypocaust system¹⁴, without, yet, attesting a regional nor a chronological correlation.

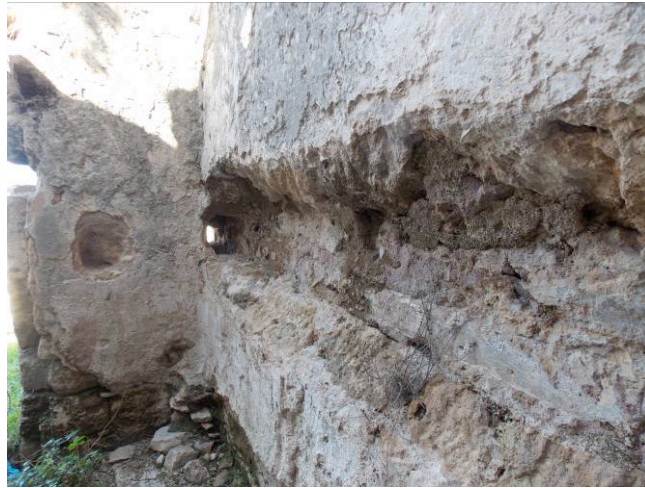
Fig. 10

Parts of vertical ceramic pipes, starting from the hypocaust, survive on the southern and eastern walls of this space. These pipes would go through walls and some of them went all the way up to the roof where smoke would be released through appropriately shaped flues (fig. 11). Parallel to the ground, at a height of about 1 m. above the ground, a ceramic pipe of 13 cm diameter, embedded in the wall of the northern and eastern side, allowed the hot air to circulate (fig. 10). Water basins fed by another system of pipes were on the eastern wall of the room.

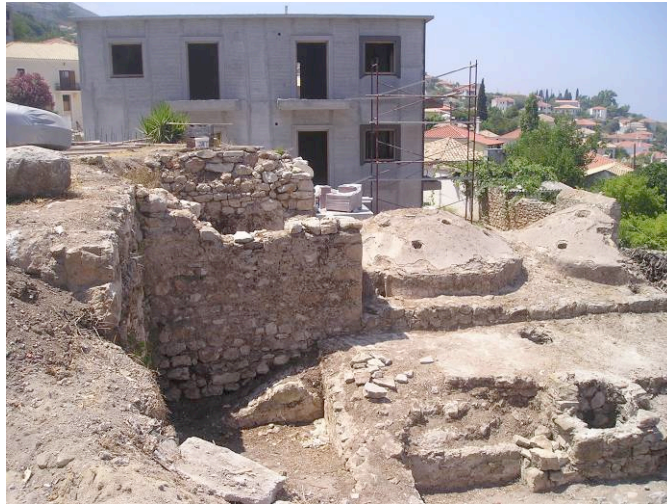
Fig. 12

To the north of the hot room there is a rectangular barrel-vaulted reservoir, the interior of which was covered with hydraulic mortar (fig. 5(2), fig. 12). Its roof, which is flat on the outside, has a glass-covered round opening, of about 30 cm diameter. The centre of the north side of the water reservoir has been adapted for the furnace (“külhan”), where a copper pot would heat the water over the fire. It is a vaulted opening with hewn stone doorposts and a brick lobe, ending in a chimney. It was originally linked with the reservoir but it was later blocked.

The next area, on the north side of the structure, is vaulted and has no openings, except the entrance on the west side (fig. 3, fig. 5(4)). It was perhaps added later, possibly in the mid-19th c. From the same period we can date the rubble walls that rise east of the central core of the hamam (fig. 5(5), fig. 12). They form part of the residence constructed on the site when the hamam was already dilapidated merely because of the great fire that devastated Kyparissia during the Greek War of Independence in 1825.

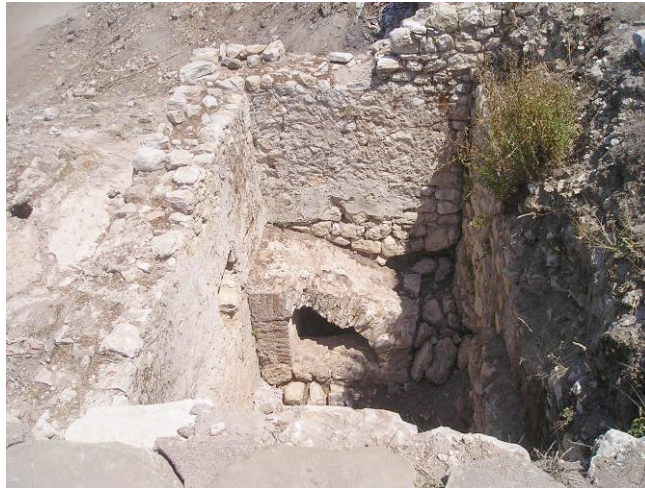
Fig. 13

The hot water reservoir was fed from a smaller tank on its east side (fig. 5(3), fig. 13). It is a brick construction, whose interior is also covered with hydraulic mortar. Parts of the pipes surviving on the eastern and western walls were probably used to provide water from the nearby fountain (“Pazarovrysi”) and to channel it to the heating compartment, as well as to the basins in the hamam’s hot room.

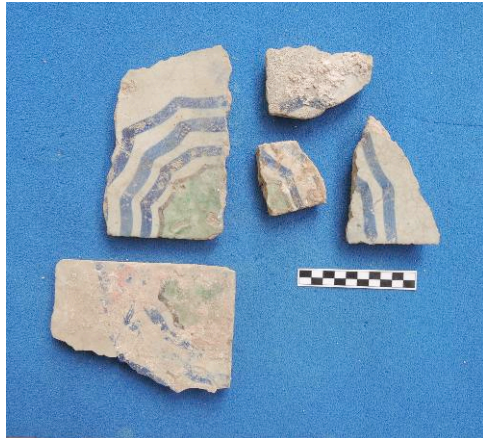
Fig. 14

Due to the hamam's dilapidated state and probably because of the simplicity of the construction, the interior is not adorned by any painted or sculpted decorative elements. Exception are fragments of glazed tiles, widely used in hamams for covering floors and walls (fig. 14). The assemblage of the finds, associated with the period during which the hammam was in operation, are few in number and fragmentary, but of great variety: ceramic ware, glazed pottery dating from the late 16/17th c. to the end of the 19th c.¹⁵, pieces of glass vessels, pipes and conduits, a silver brooch. Among the numerous coins we can identify two Venetian copper coins

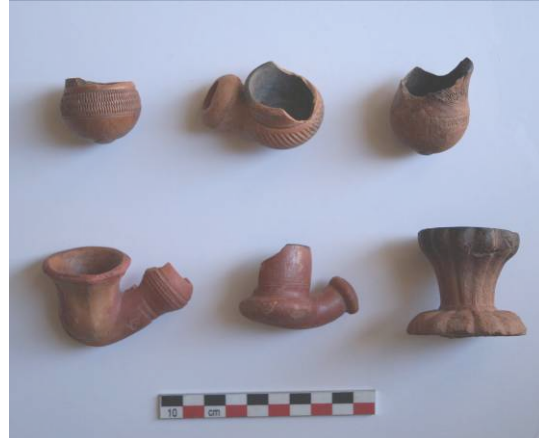
Fig. 15

of 1684-1710¹⁶ and a silver Ottoman coin from the 18th century (kurush, Egypt -Cairo Mustafa III (1757-1774)). Of particular significance are the clay tobacco pipes that date from the late 17/18th c. to the 19th c.¹⁷ as well as a smoking water pipe (*narghile*) of the 18th c. (fig. 15)

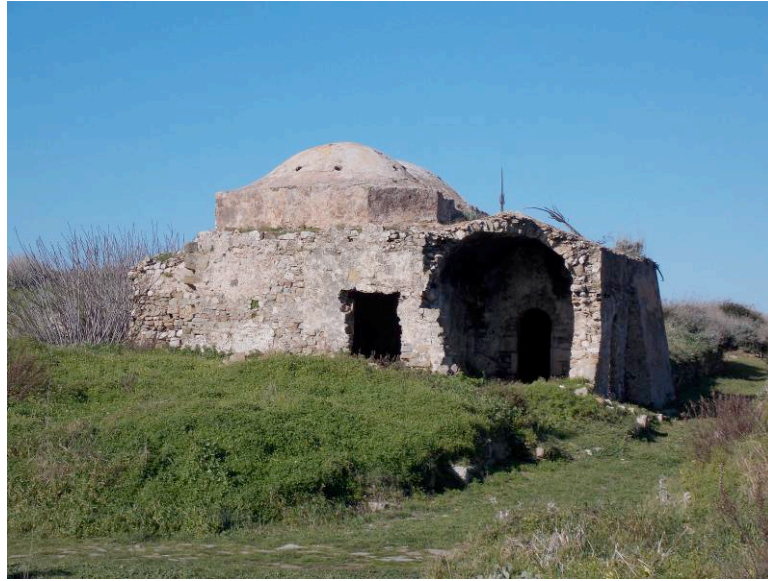
Fig. 16

Two Ottoman baths are located within the walls of the castle in Methoni, the biggest port town in Messenia, built some 200m. from each other.¹⁸ Evliyâ Çelebi, who visited the castle in the mid-17th c., mentions the existence of only one public bath¹⁹. The first (A), northern building consists of 4 rooms and a vaulted reservoir with the furnace (fig. 16 - 17). On the north side there is a vaulted two-part room which could be identified as the tepid room, an antechamber for the two hot rooms. Light enters the space through round openings in the vault and the space is heated with ceramic pipes running along the walls and coming from the hot rooms. The latter are almost square and joined with a low arched door. They are vaulted and the octagonal base of the domes is mounted on squinches while large glass-covered round openings allow for proper lighting. The domes were constructed by rough-hewn stones with fragments of bricks in the same way as the rest of this building's walls. A double row of bricks on the eastern side of the structure is still visible.

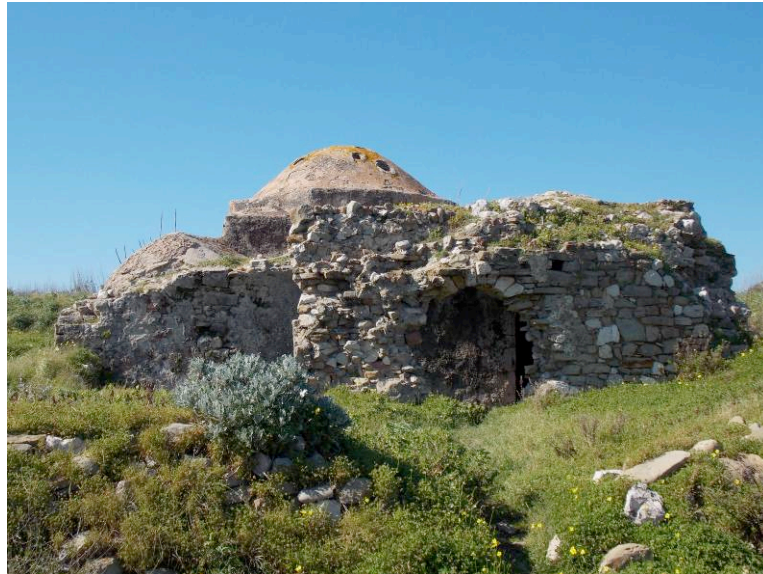
Fig. 18

The second (B), southern hamam presents a more complex structure with additional and smaller auxiliary spaces (fig. 18 - 19). Three basic compartments can be seen: the furnace with the water reservoir, the tepid and hot rooms and a small vaulted antechamber along the eastern side of the building. A further small private hot air compartment (“halvet”), is formed next to the eastern hot section. An interesting detail is a small niche with a stone arch used for depositing functional bath objects. The hot rooms are covered by semispherical domes with rectangular light holes and mounted on pendentives. We can still detect some interesting morphological features such as the hypocaust heating system under the floors, traces

of basins on the side walls of the hot rooms, the rectangular light holes in the domes and the vault of the tepid room. Similar openings have only been found in one other Ottoman bath in Chania, which was constructed between 1669 and 1898²⁰. The masonry is of rubble stone with the occasional use of brick and tile fragments.
