THE RED CHURCH AT SİVRİHİSAR (CAPPADOCIA): ASPECTS OF STRUCTURE AND CONSTRUCTION

Robert Ousterhout

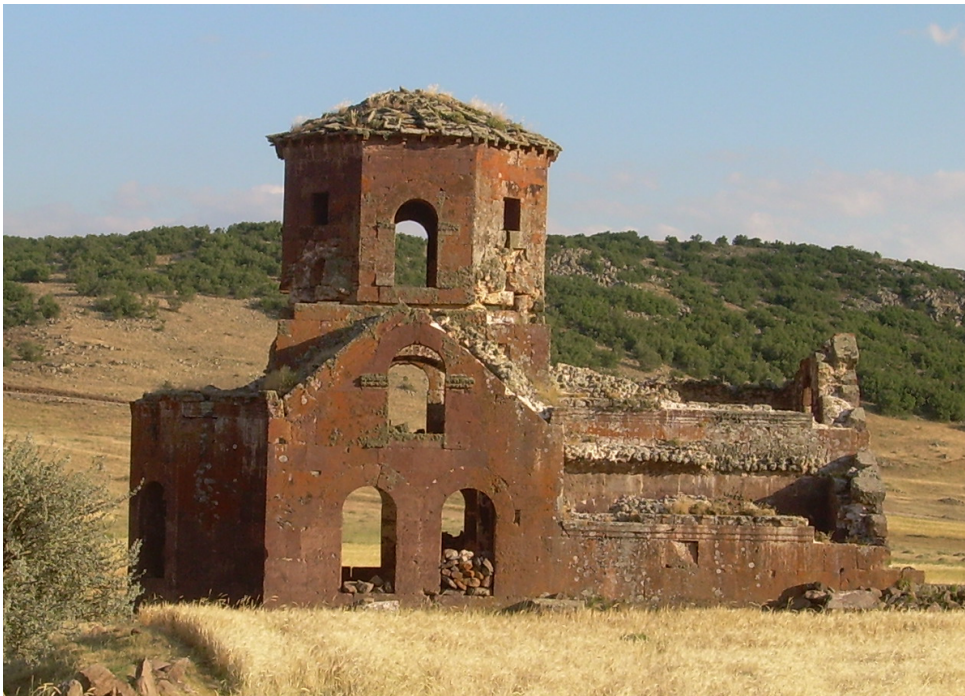
Fig. 2. Same, view from the north (author)

Curiously the extradoi of the vaults appear to have risen higher than the gables that terminate the facades (see Fig. 2). This puzzled me for a long time, but in older photos and still below the roof over the dome, the cornice is surmounted by a dentil course. This survives in a few places (visible in Fig. 6, center), but there were more *in situ* when Gertrude Bell photographed the church in 1907. As her drawing shows, this would have doubled the height of the cornice. If the dentil course extended over the gables, it would have provided the additional height necessary to face the vaults.¹¹

The vault over the side aisle has an unusual profile, actually closer to a quadrant vault than to a barrel vault, as it is usually represented (Fig. 7). Seen from the exterior it is clear that the inner springing is considerably higher than the outer springing, and that the profile is flattened and sloping, as is evident where it once joined the transept (see fig. 2). This vault

unusual – I know of nothing similar, although we see a similar lack of transition to dome in some of the chapels at Binbirkilise, or the octagon at Sivasa, now destroyed.¹² While the squinches were built of ashlar, it is unclear how they were finished on the exterior (see Figs. 2 and 6). They were already deteriorated a century ago, when Rott and Bell visited.

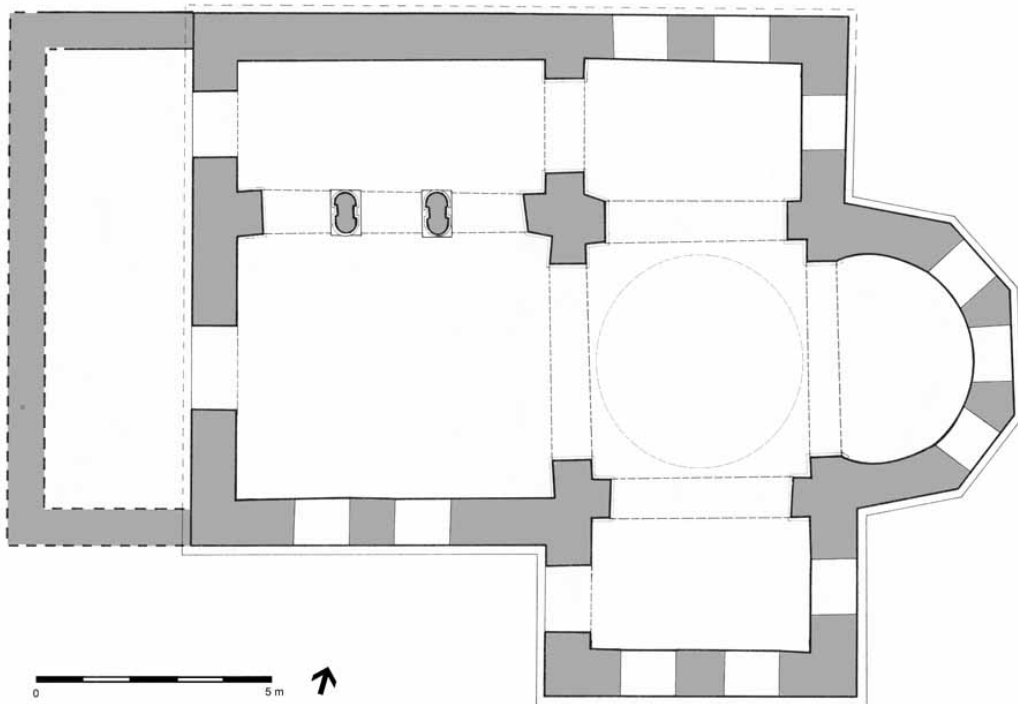
Constructed on a Latin cross plan, the Red Church has a nave span of about 5.6 m. Overall the interior (minus the apse) has square proportions, measuring 12.5 m in length and width internally (Fig. 3). There is a single side aisle to the north of the nave, although none to the south, where a portal opens into the transept. As with the arches in the building, the apse is horseshoe-shaped on the interior. A narthex fronted the building to the west, now mostly destroyed, with doorways opening into the nave and aisle. Although most scholars have dated the narthex later because it was not bonded to the main block of the building, I believe it was contemporary. Probably originally open in form and covered by a wooden roof, the lack of bonding was undoubtedly to allow for differential settlement, as the rest of the building was vaulted throughout and considerably heavier, and it would have required stronger foundations.

Fig. 3. Same, plan (author, redrawn after Restle)

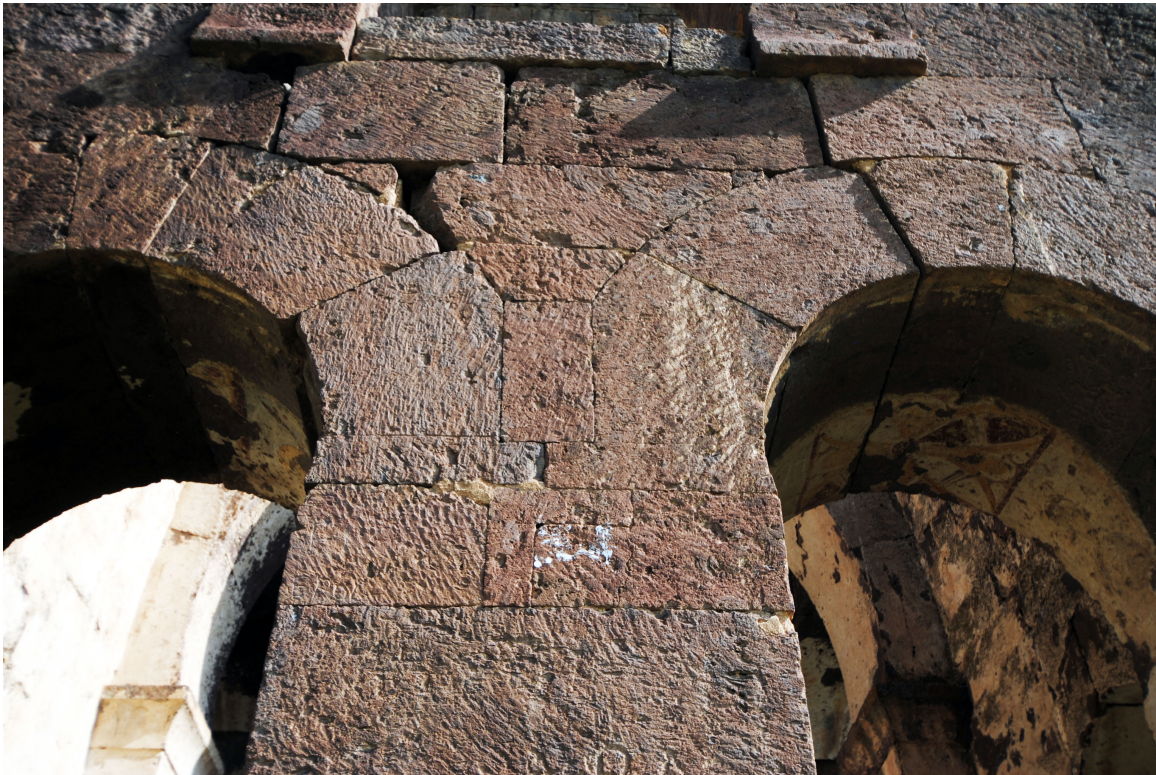
in an almost jigsaw-like manner, as seen in a detail of the south façade (Fig. 4). The interior surfaces are a mix of ashlar masonry and mortared rubble. Around doors, windows, and at the main supports, the fine ashlar is similar to that on the exterior. Elsewhere the walls are a rougher ashlar, particularly rough at the level of the foundations, below the windows. Traces of painted plaster survive throughout the building, indicating the inner surfaces were entirely covered originally, and thus the rough ashlar would not have been visible.

Fig. 4. Same, south façade, transept, detail of masonry construction (author)

One final detail is worth noting. While almost all the arches in the church are horseshoe in shape, most of them have incised horizontal lines on the impost blocks (see fig. 4). These lines mark the actual springing of the arches – that is, where the semicircle begins. Sometimes there is a double line at this point. The purpose of these is not immediately obvious, although it is certainly not decorative. I suspect it might have something to do with the stereotomy of the blocks – that is, to calculate the geometry of the voussoirs when they were carved, before they were hoisted into place. These would be somewhat similar to the lines noted on the floor of the church of St. Sergius at Resafa, which were remnants of

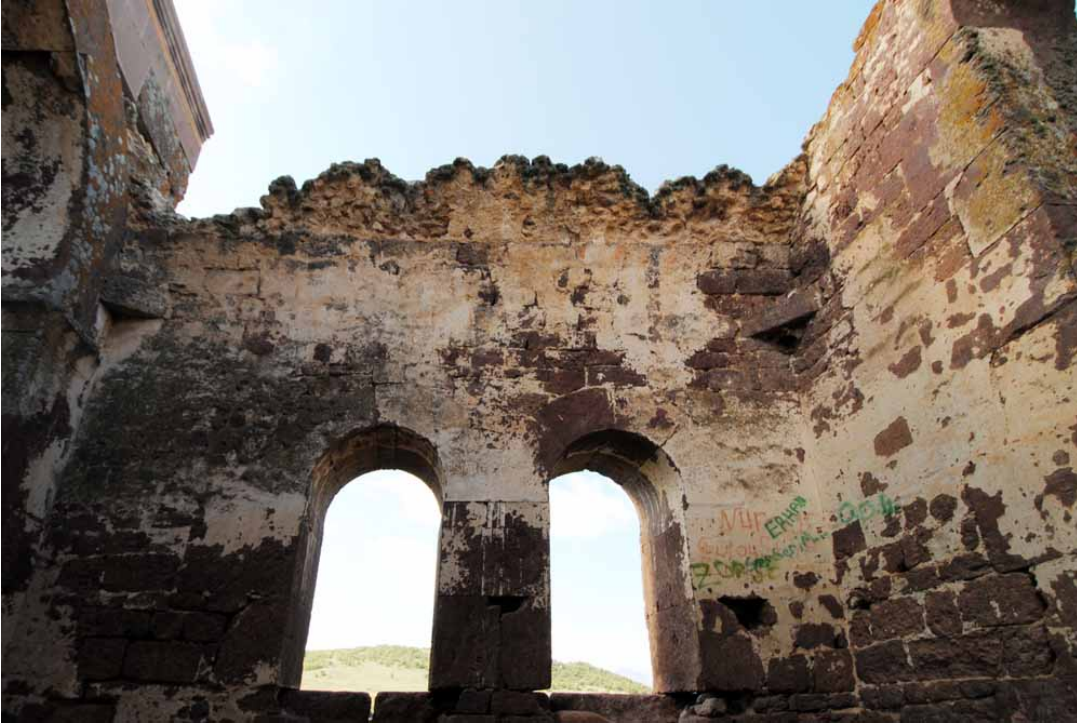
More curious is the change from ashlar to mortared rubble in the vaulting (Fig. 5). In the nave this begins three courses above the springing, elsewhere three to five courses above, but in all where the curvature of the vault extended beyond what could be supported without centering. This also corresponds to the height of the walls on the exterior. The conch of the apse was also constructed of mortared rubble. At the Red Church, the rubble vaults were laid directly on the centering, without facing, in several courses. On the joints between the courses of rubble are visible on the exterior (Fig. 6). None of the rubble vaults survive intact, and clearly, these were the weakest points in the construction.

Fig. 5. Same, interior of the nave, looking south (author)

There is no symmetrical aisle and vault to brace the nave vault on the opposite side. At the corners of the south wall, however, brackets extend across the corners to reinforce the bond between the unbuttressed south wall and those to either side (visible in Fig. 5). Placed at the springing of the vault, it is unclear how effective they would have been.

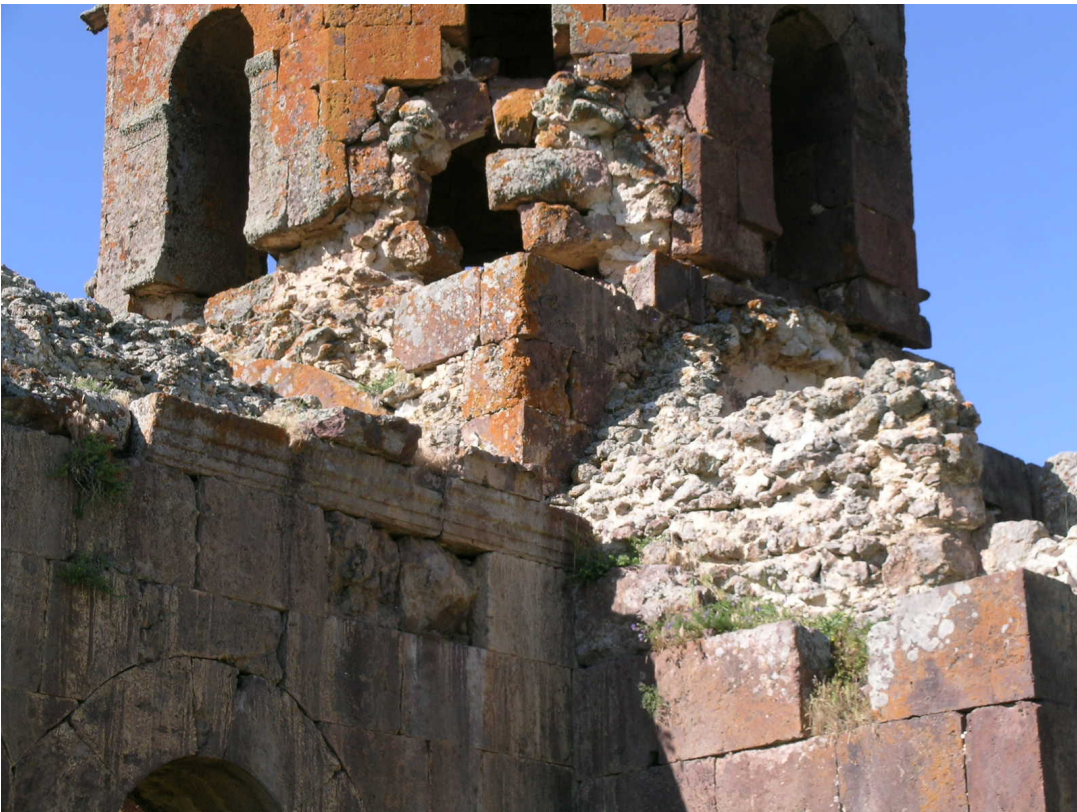
Fig. 6. Same, detail of exterior from the southwest at the corner of the nave and transept (author)

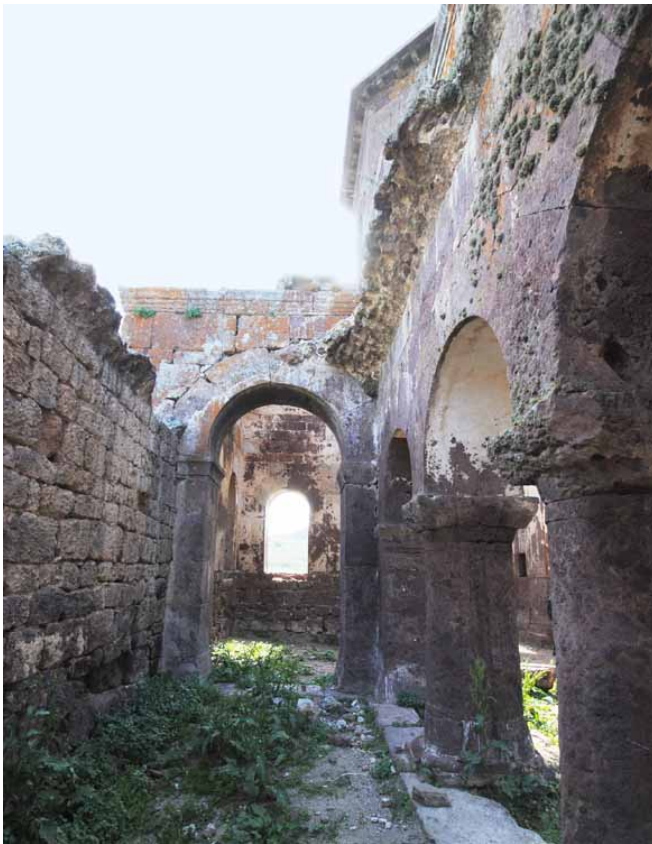
Fig. 7. Same, side aisle, looking east (author)

played an important role is stabilizing the outward thrust from the high vault at its springing, and this must have motivated its odd profile.

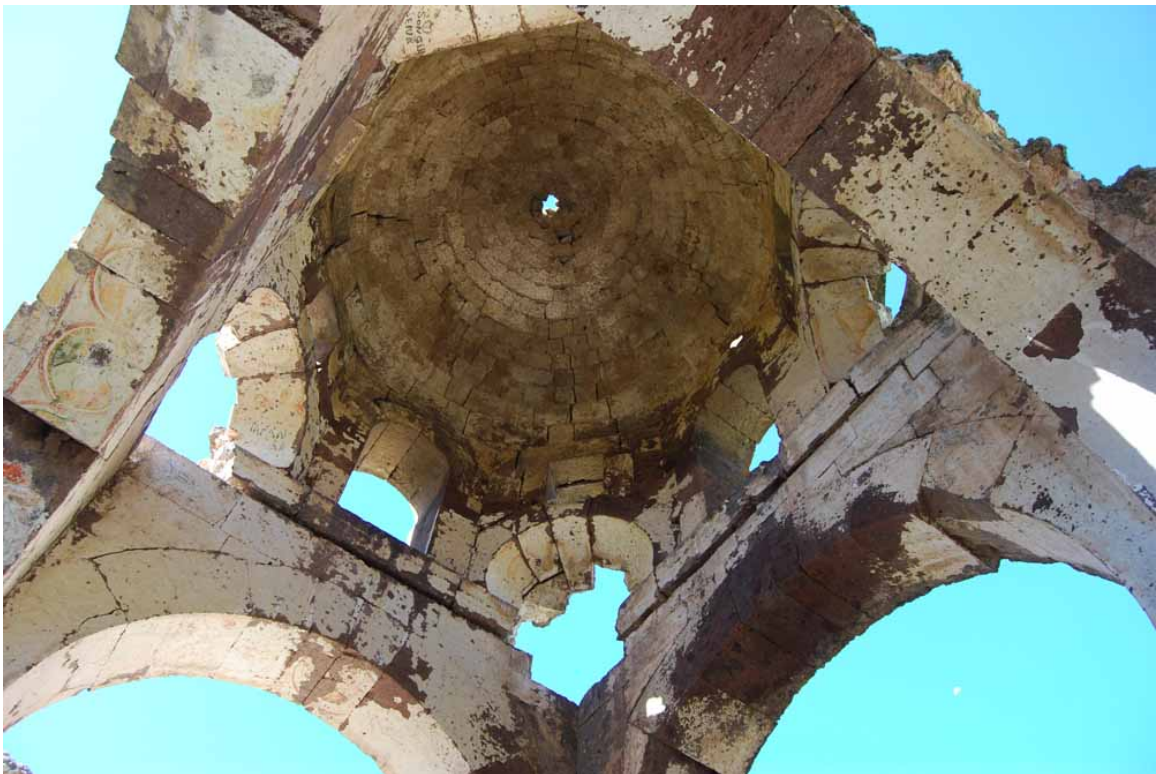
Fig. 8. Same, view into dome (author).

Of the vaults of the Red Church, only the dome itself was constructed of ashlar, and it is the only vault that remains intact. It rises above a tall octagonal drum, with squinches to make the transition to the square crossing bay (Fig. 8). The dome rises directly from the drum, without a transition from octagon to circle. The squinches are actually expanded corner conches, circular at their base, projecting beyond the cornice. Large windows appear in the axial segments of the drum, while small square windows appear above the squinches, covered by pi-shaped lintels immediately below the springing of the dome. The latter are

Perhaps the most unusual feature of the dome is the bracing at the base of the drum. Immediately beneath the interior cornice was a single course of wood, which originally extended around the four sides of the crossing. Several pieces were still in place when Gertrude Bell photographed the church in 1907, and one still survives today (see Fig. 8). The vacant channel was filled by new beams in the recent restoration, undertaken to stabilize the dome. Curiously, a similar channel appears at exactly the same level on the exterior, one stone course below the windows, and this also must have contained wooden bracing extending around four sides of the building (see Figs. 2 and 6). Although the reinforcement was no doubt effective while the wood was intact, once it had deteriorated or fallen away, it destabilized the dome at a critical point by thinning the base from both the interior and the exterior. Probably this accounts for the deterioration of the squinches, whose exterior rested on the wood beams at the corners. This was one of the chief concerns that led to recent conservation measures, which replaced the wooden supports, inside and out, renewed the missing masonry immediately around this area, and replaced the roof tiles.
