# The Contamination of Lake Atitlan, Its Implications and Possible Solutions

A Senior Thesis by Raleigh L. Davis

University of Pennsylvania, Department of Earth and Environmental Science

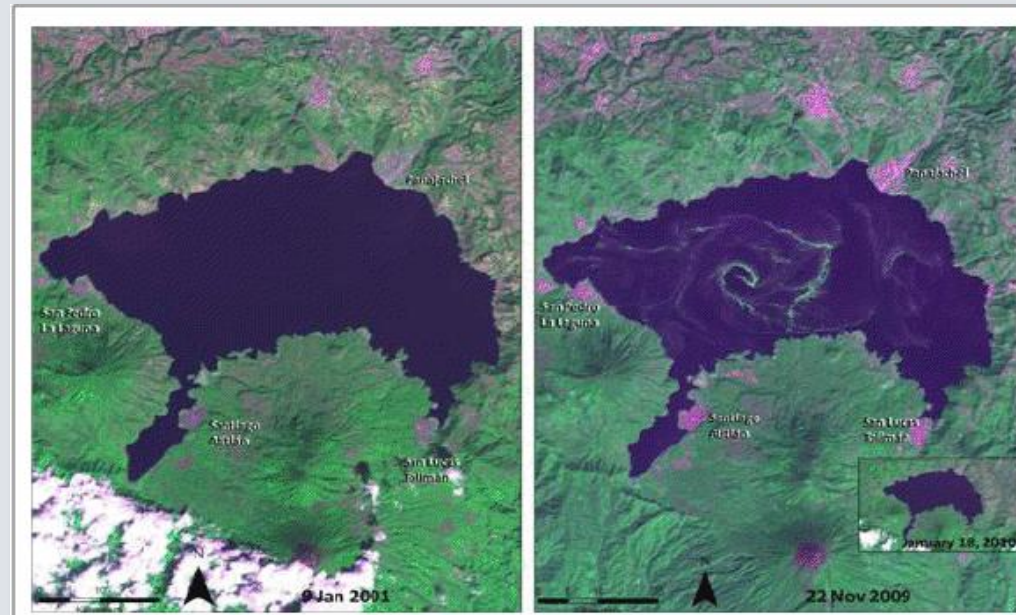
Figure 4: Cyanobacteria Bloom of 2009. Giron 2009

The first widespread cyanobacteria bloom was in December of 2008, and there was a second, more extensive one in October of 2009. The first bloom was extremely localized, and lake was cleared by the end of January 2009. The second bloom started in October, most likely due to upwelling, and spread quite rapidly. The bloom was formed *Lyngbya robusta* species of cyanobacteria and it was the first bloom of this specific species. The Figure to the right shows the cyanobacteria bloom at its peak, when it covered roughly 40% of the 137 km<sup>2</sup> lake area in 2009. This cyanobacteria was not toxic, but was extremely odorous and very unpleasant to observe. Research cite the uncontrolled nutrient inputs into the lake as the catalyst that sparked the bloom. Phosphorus levels were extremely high, and there was a low N:P ratio. As of now, the bloom has gone away, but there is still constant fear that another will return, since sampling has shown that the algae is still present in the surface waters of the lake.

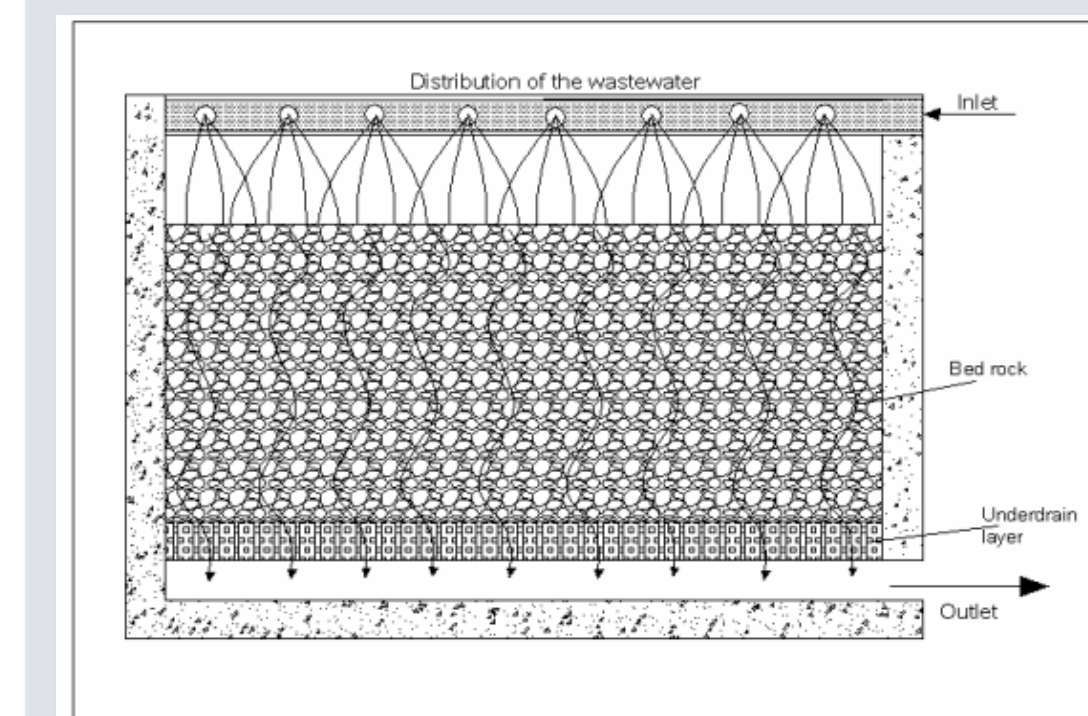
Figure 8: Basic Biofilter. Dobias and Leshhem 2008

At first glance, the situation appears to be somewhat helpless. Implementation of a western wastewater treatment plant may be good in theory, but is probably not the best answer due to limited local knowledge and previous failures. With regards to the nutrient input, raising public awareness will most likely be the best knowledge. To make farmers aware that they can still make a profit while farming sustainable would hopefully result in less cash crops, lower fertilizer use and lower rates of soil erosion. If nutrients levels remain low, then the cyanobacteria problem/eutrophication can be managed. Due to the size of the lake and its surrounding population, many of the chemical and mechanical options for the sewage problem are not feasible. One idea that has become increasingly popular is the creation of wetland-like environments to filter the collected wastewater. This option is currently only feasible in municipalities where wastewater is collected. There is also the possibility of retrofitting homes so that sewage could be collected, but that would be an extremely expensive option. A more plausible one would be the installation of basic filtration systems in the seepage pit, to capture the bacteria before it gets transported through the rock. This can be seen in Figure 8.
