Indian Ocean tsunamis: environmental and socio-economic impacts in Langkawi, Malaysia

We report the results of a study of the physical characteristics and socio-economic impacts of the Indian Ocean Tsunami of 26 December 2004 on the tourist island of Langkawi, Malaysia. In comparison with many other locations struck by the tsunami, the immediate physical and socio-economic impacts in Langkawi were relatively minor. A detailed survey of the watermark and ground elevations was undertaken in the worst affected area between Sungei Kuala Teriang and Sungei Kuala Melaka. Here, the tsunami reached a maximum elevation of 4.29 m as it crossed the coast, with a maximum flow depth of 2.0 m and a very consistent run-up elevation relative to mean sea level of 300 ± 10 cm. The tsunami inundated inshore areas for 300 m and penetrated inland along creeks for 500–1000 m. Structural damage to buildings was confined to within 50–150 m of the shoreline where about 10% of the houses were completely destroyed and 60–70% suffered significant structural damage. Damage was particularly severe in areas where there was no engineered coastal protection, but while coastal revetments did provide enhanced prote

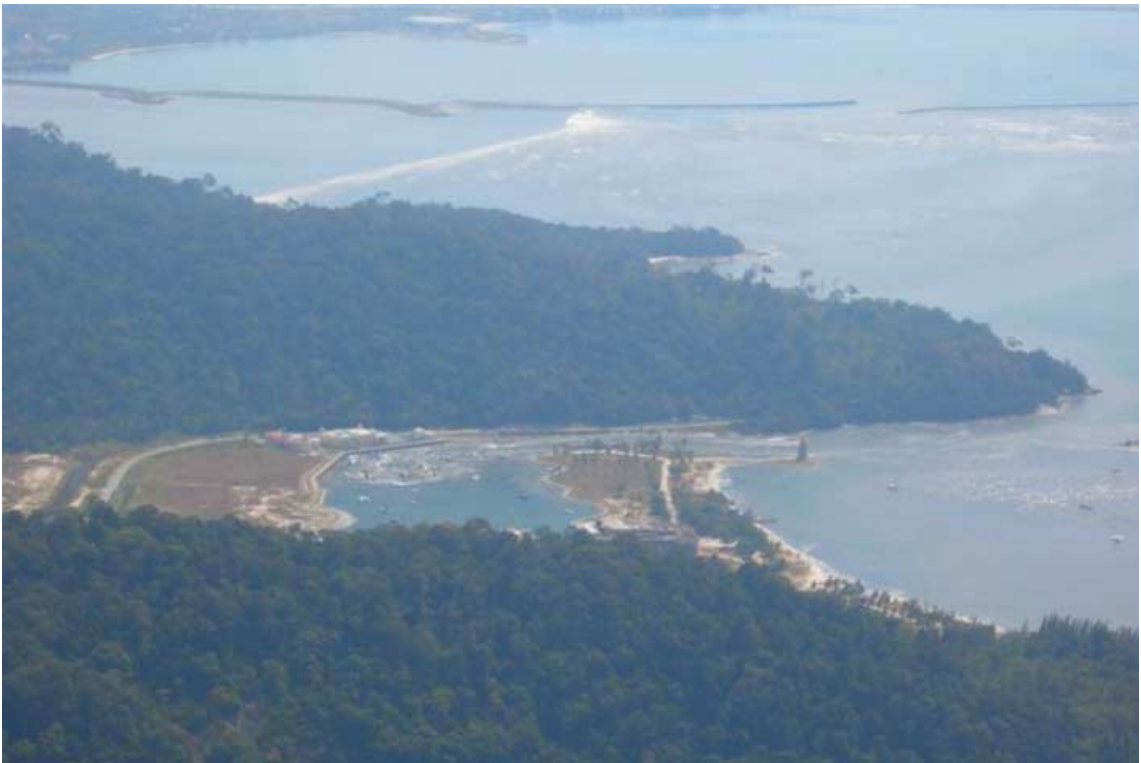
Plate 1 View looking ESE from the Langkawi cable car at 12:25 pm as the first wave approached the study area, which is just out of view in the top left. The wave has already entered the Telaga Harbour Marina in the centre of the picture, and is in the process of sweeping away both moorings and boats. The breakwater protecting the Langkawi Airport and Port Langasuka is visible across the top of the picture

12:18 pm, 193 minutes after the earthquake, suggesting an average speed *en route* of at least 240 km/h. After passing Telaga Harbour, the wave refracted around Tanjung Belikit, aligning parallel with the coastline in the study area and travelling north-eastwards at 25–30 km/h through progressively shallowing water. A single, approximately linear wave crest was 2 km from Kuala Teriang at 12:25 pm and struck the coast approximately 4 minutes later, progressively constricted between the steep natural coastline to the north and the artificial breakwater that protects the airport to the south (Figure 2). The approach of the wave resulted in a drawdown of sea level that exposed a substantial proportion of the Port Langasuka breakwater 700 m offshore (Plate 1).

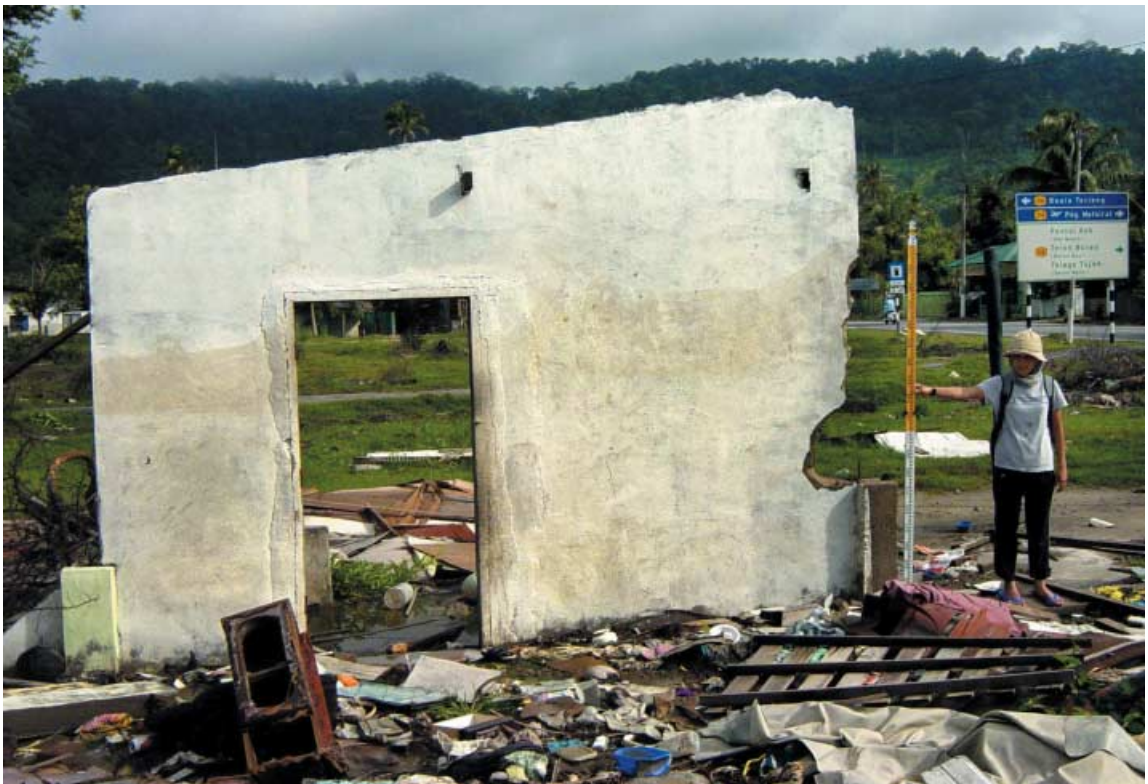
Plate 2 Looking north at a watermark recorded as 383 cm (elevation of water above MSL), 160 cm (water depth) in Figure 2, in the zone of maximum damage between Kuala Teriang and Kuala Melaka. This is the only wall of this brick house that was left standing. The wall is oriented perpendicular to the flow, which was from left to right. A brown watermark slopes irregularly upward from 140 cm above the ground to the left (marked by an arrow), to 180 cm to the right. The main road through the Kampong is visible in the background

completely destroyed (two or fewer external walls standing), while around 60–70% suffered significant structural damage to one or two external walls and/or the roof, with the extent of damage decreasing rapidly away from the coast (Plates 2 and 3).

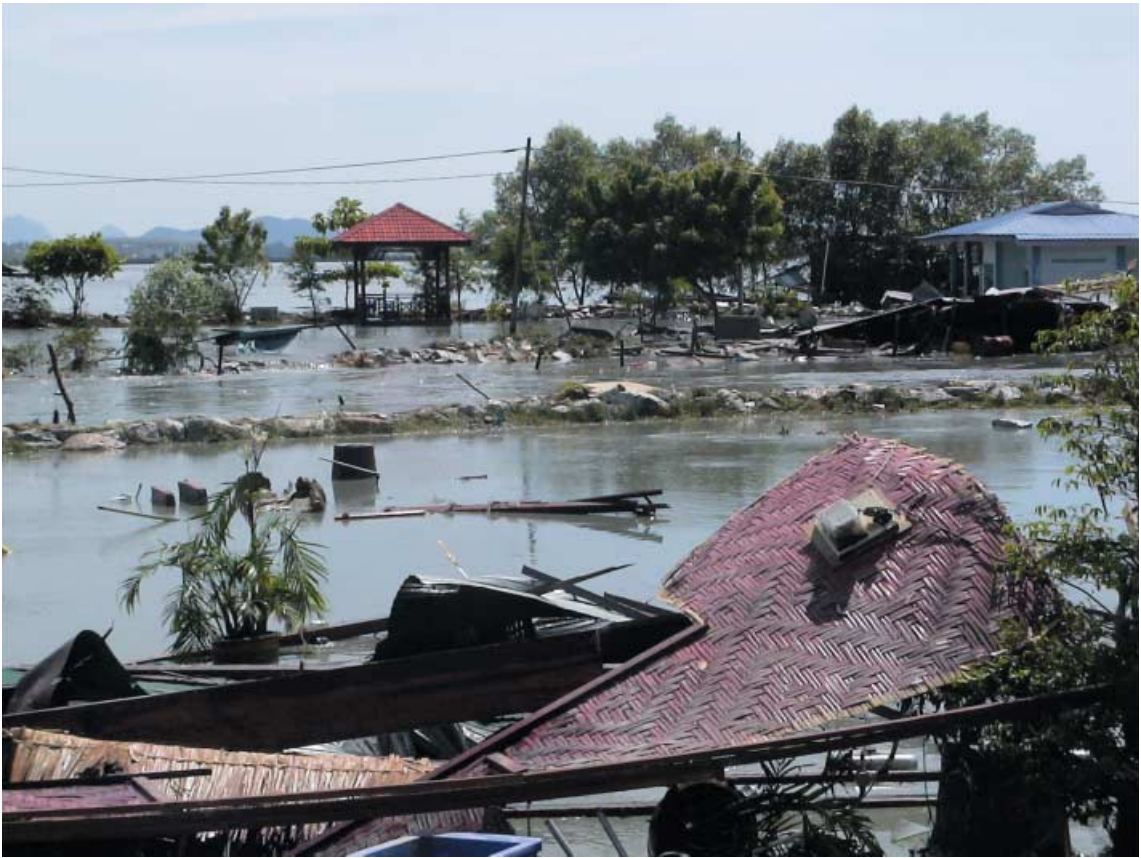
Plate 3 Damage in the immediate aftermath of the tsunami looking south from the main road at 6.3629°N, 99.7111°E, across Sungei Ranggor Besar (marked by rock revetments just exposed above the retreating tsunami water) and out to sea

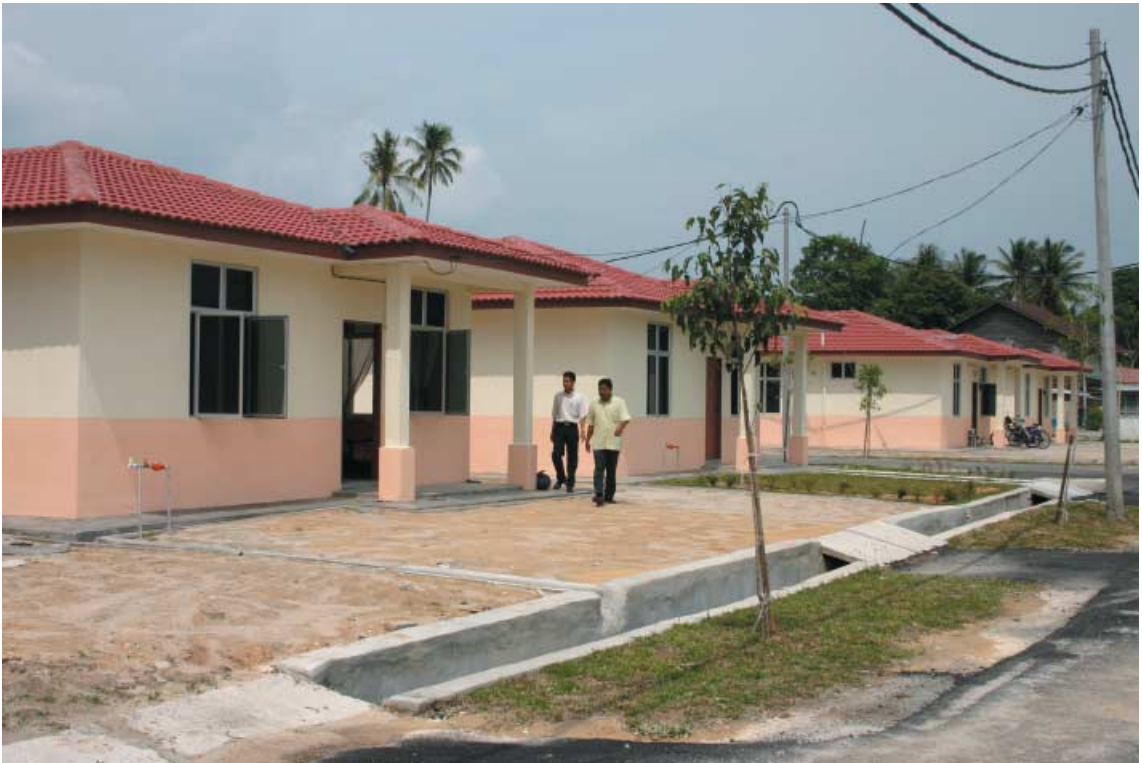
Plate 4 New housing adjacent to Sungei Ranggor Besar in Kuala Teriang, constructed to replace housing destroyed by the tsunami
